1. INTRODUCTION

This Inspection Report includes findings and observations concerning the National Pollutant Discharge Elimination System (“NPDES”) Stormwater Inspection (“Inspection”) conducted by José A. Rivera, Lead Environmental Engineer, Clean Water Act Team (the “EPA Inspector”), of the United States Environmental Protection Agency’s (“EPA”) Caribbean Environmental Protection Division (“CEPD”) at the Aguadilla Pier, Corp. (“Aguadilla Pier” or “APC”) property located in Aguadilla, Puerto Rico (the “Site” or “Property”). **Image 1** (below) depicts an aerial imagery of the Site found in Google Earth Pro™, with imagery dated June 11, 2017.

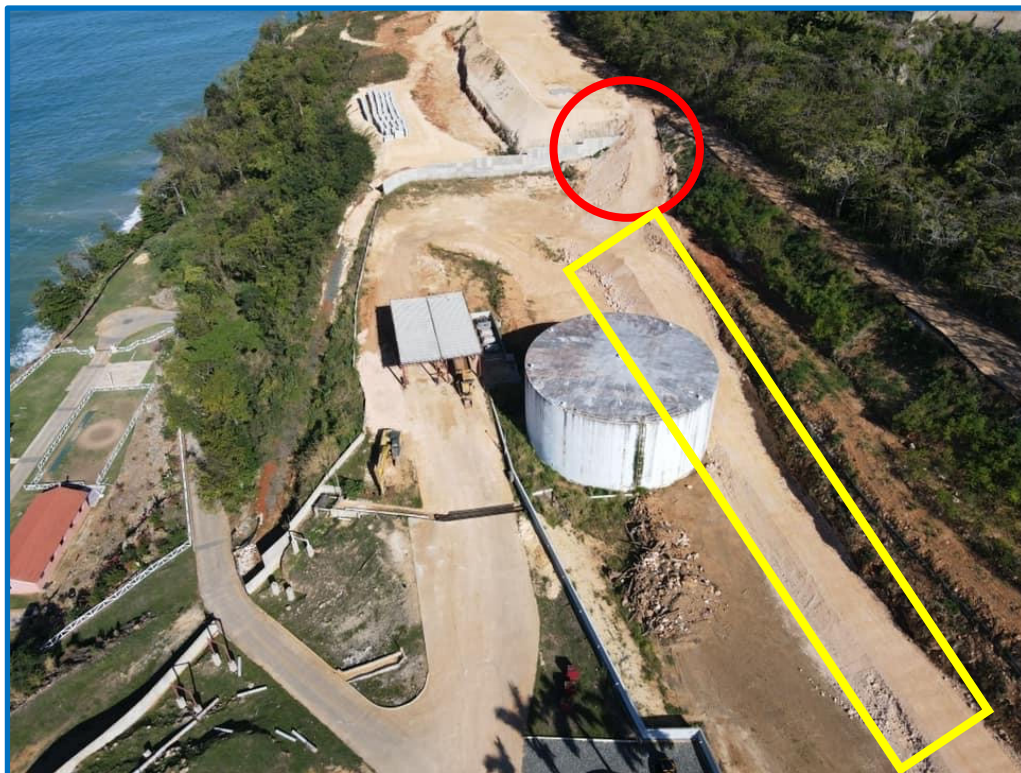
Image 10 (next page) depicts the access road (red-colored circle) and stockpile (yellow-colored rectangle). As such, two areas of the Site have been used for stockpiling in support of the The Cliff project.
